# Manhole Inspection Summary

Manhole # S23KK\_062MH

**Location** Address: **2445 ETING ST**

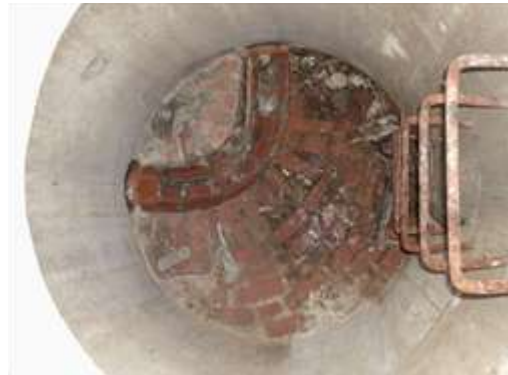
Top View

Corroded steps. Evidence of surcharge - Bench debris. Channel debris.

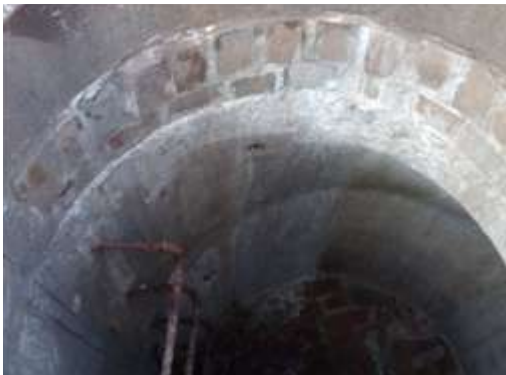
Defect

**Frame** Offset: **0** (in.) Condition: ☐ Sound ☐ Cracked ☒ **Leaks**

Condition: ☐ Sound ☐ Cracked ☐ Root Intrusion ☐ Loose Brick ☒ **Deteriorated**

Infiltration: ☐ None ☒ **Joint** ☐ Cracks ☐ Mortar ☐ Roots ☒ **Wall**

Frame leaks. Adjustment deterioration and infiltration.

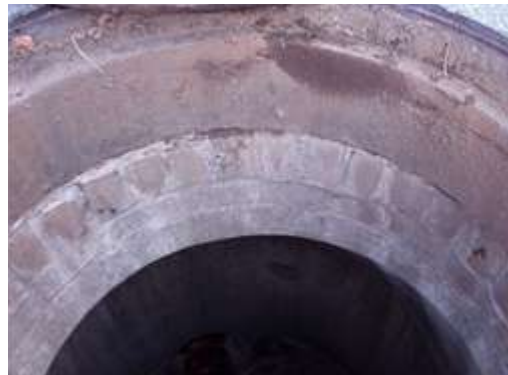
Defect

Frame leaks. Adjustment deterioration and infiltration - other side.

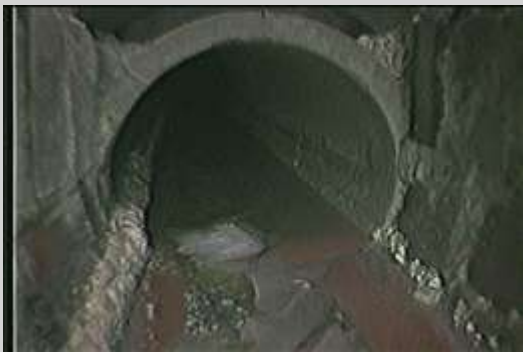
### 8 in. Circular Gravity Sewer Pipe Out @ 12 O'Clock

Deposits: ☐ None ☐ Mud ☐ Sludge ☐ Debris ☒ Grease

Silt Depth: **0** (in.) Deposits Extent: **Light**

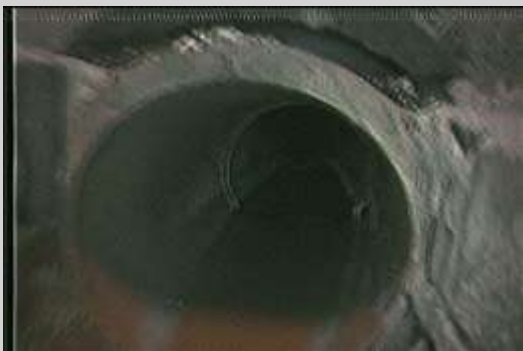
### 8 in. Circular Gravity Sewer Pipe In @ 9 O'Clock

Infiltration: **Evidence** Pipe Seal Cond: **Unknown**
